A SURVEY OF SERIOUS AIRCRAFT ACCIDENTS INVOLVING FATIGUE FRACTURE

VOL. 2 ROTARY-WING AIRCRAFT

National Aeronautical Establishment

NAE-AN-8

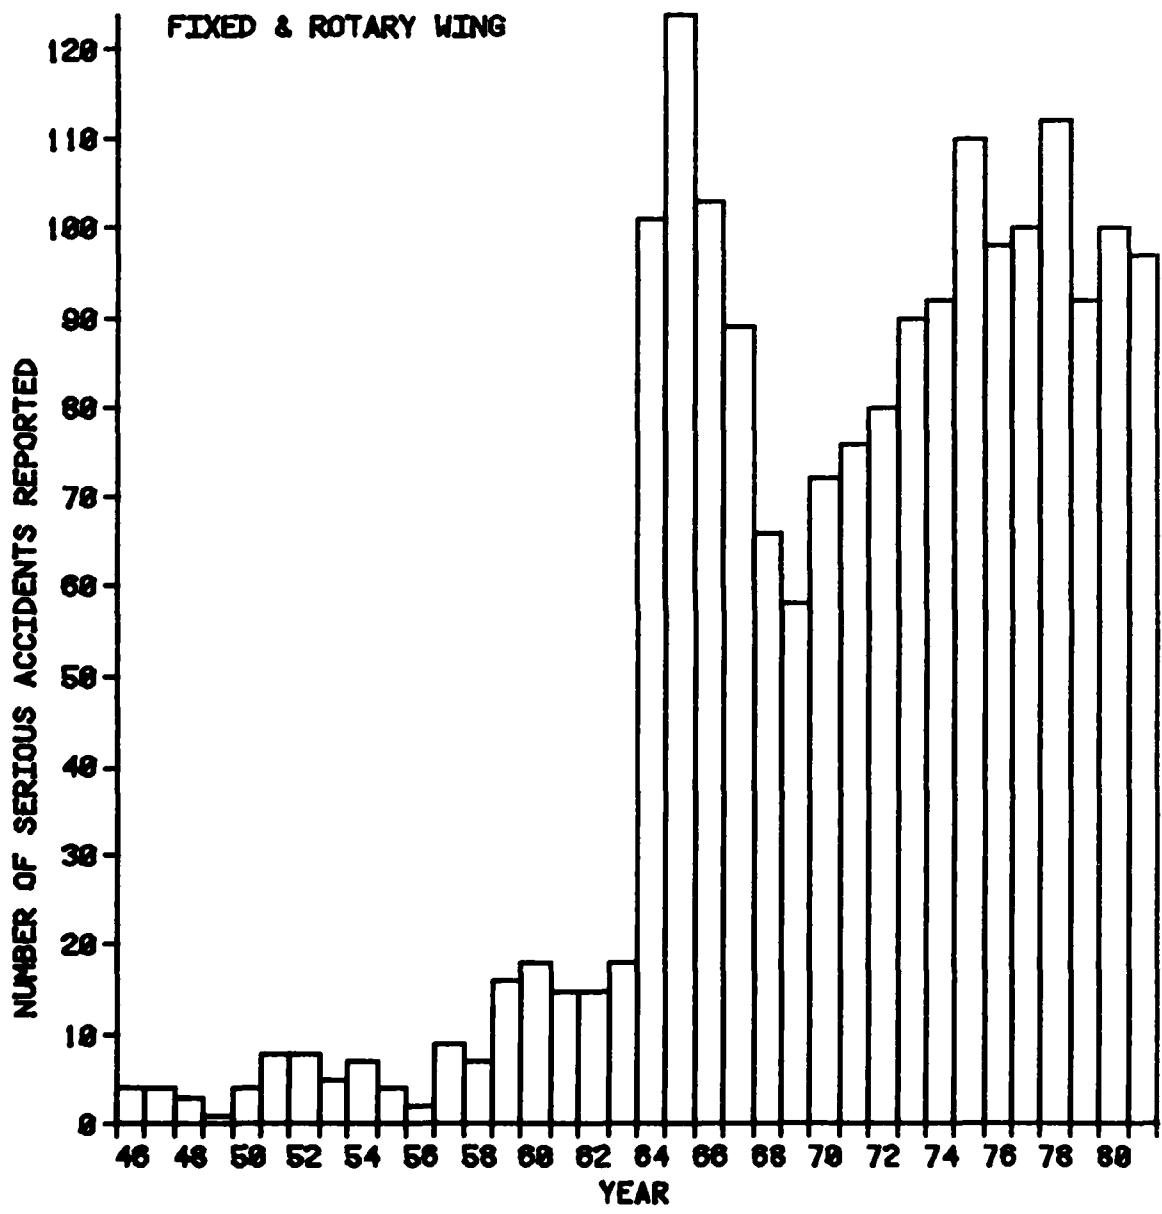
FIG. 1 NUMBER OF SERIOUS FATIGUE ACCIDENTS
- FIXED-WING & ROTARY-WING

The total number of reported fixed-wing plus rotary-wing accidents occurring in each year is plotted in Figure 1. The big increase in the mid-1960s is the result of improved availability of accident information with the introduction of computer-based information systems in a number of countries (particularly the introduction of the US National Transportation Safety Board system in 1964). Over the last five years there has been an average of 100 fatal accidents (fixed-wing plus rotary-wing) per year resulting from metal fatigue.

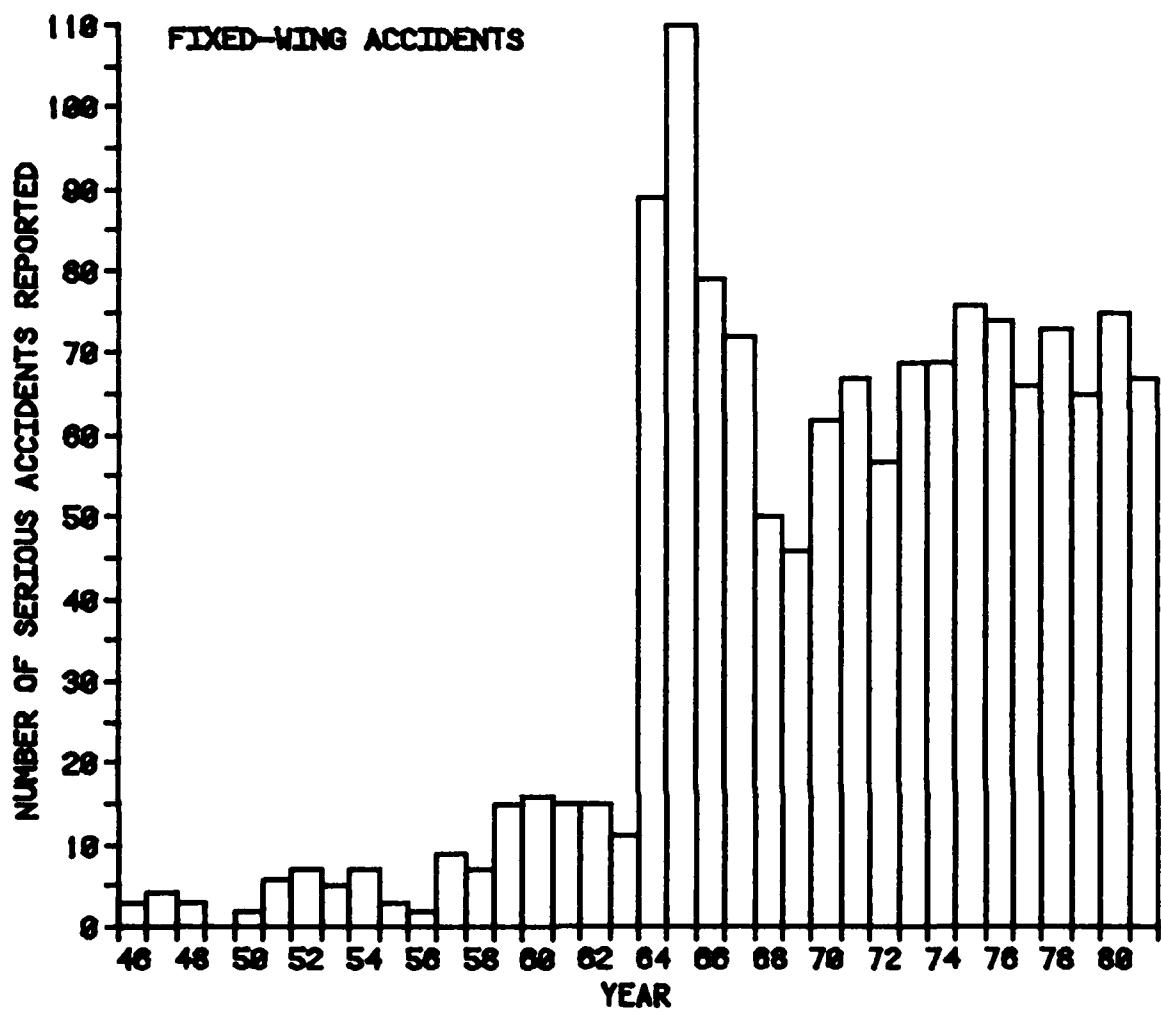
FIG. 2 NUMBER OF SERIOUS AIRCRAFT ACCIDENTS
- FIXED-WING

The number of fixed-wing accidents for each year is plotted in Figure 2, while the number of rotary-wing accidents is shown in Figure 3. Averaged over the past five years, rotary-wing aircraft have had 31 serious accidents per year.

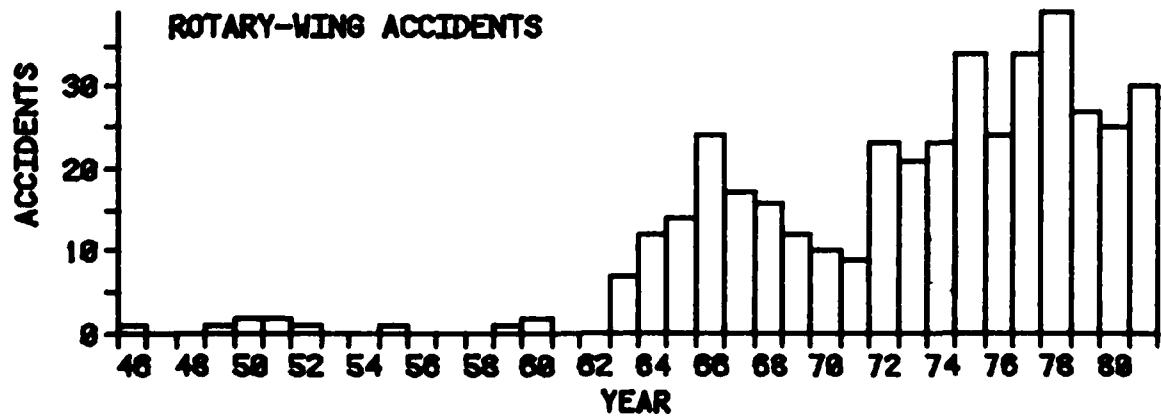
FIG. 3 NUMBER OF SERIOUS AIRCRAFT ACCIDENTS
- ROTARY-WING

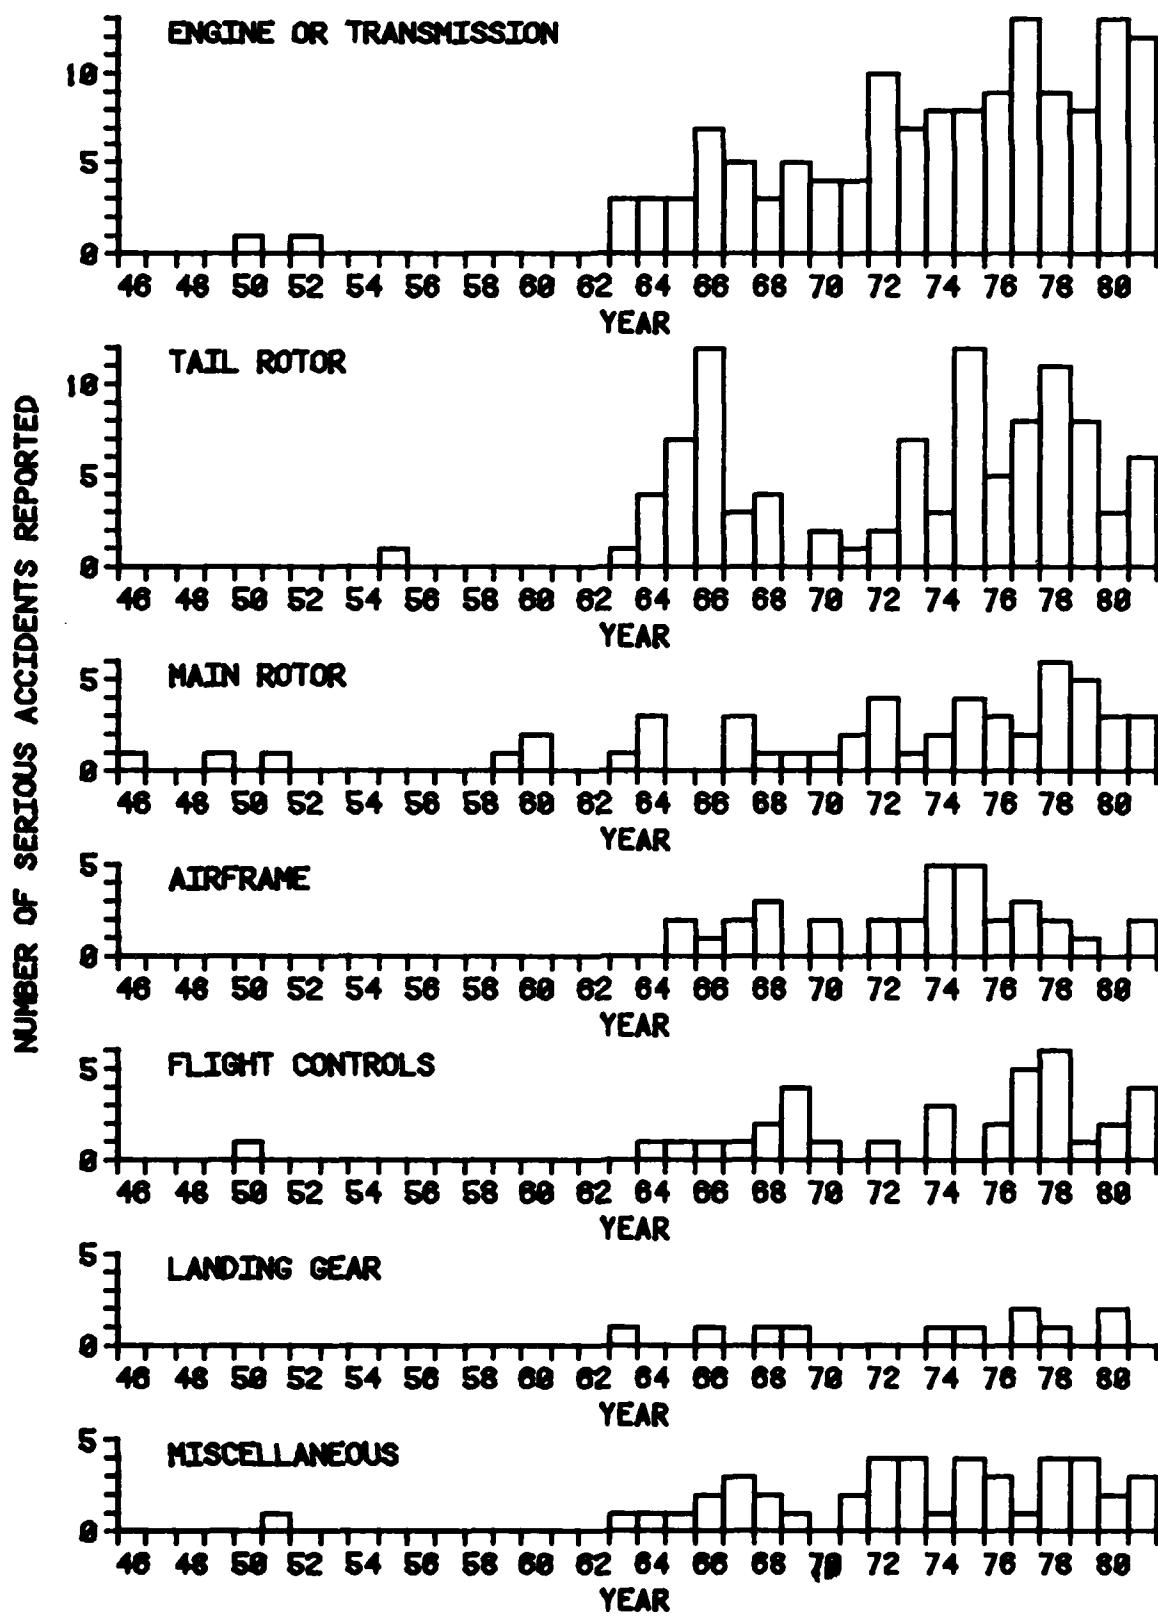
FIG. 4 CAUSES OF FATIGUE FAILURES - ROTARY-WING AIRCRAFT

Figure 4 shows the breakdown of rotary-wing accidents by failure type. Since 1976, engine/transmission fatigue failures have been the most common accident cause, with 11 accidents per year on average, followed by tail rotor problems (7 per year), and failures in the main rotor system (4 per year).
